SKYLAB MISSION REPORT
FIRST VISIT

PREPARED BY
Mission Evaluation Team

NATIONAL AERONAUTICS AND SPACE ADMINISTRATION
LYNDON B. JOHNSON SPACE CENTER
HOUSTON, TEXAS
August 1973

This report constitutes the Johnson Space Center's evaluation of the first visit. The report is presented in two parts, and contains the information available 30 days after the completion of the first manned visit.

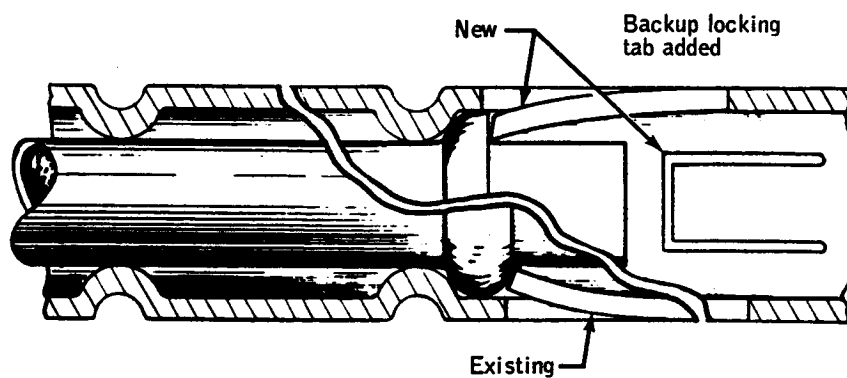
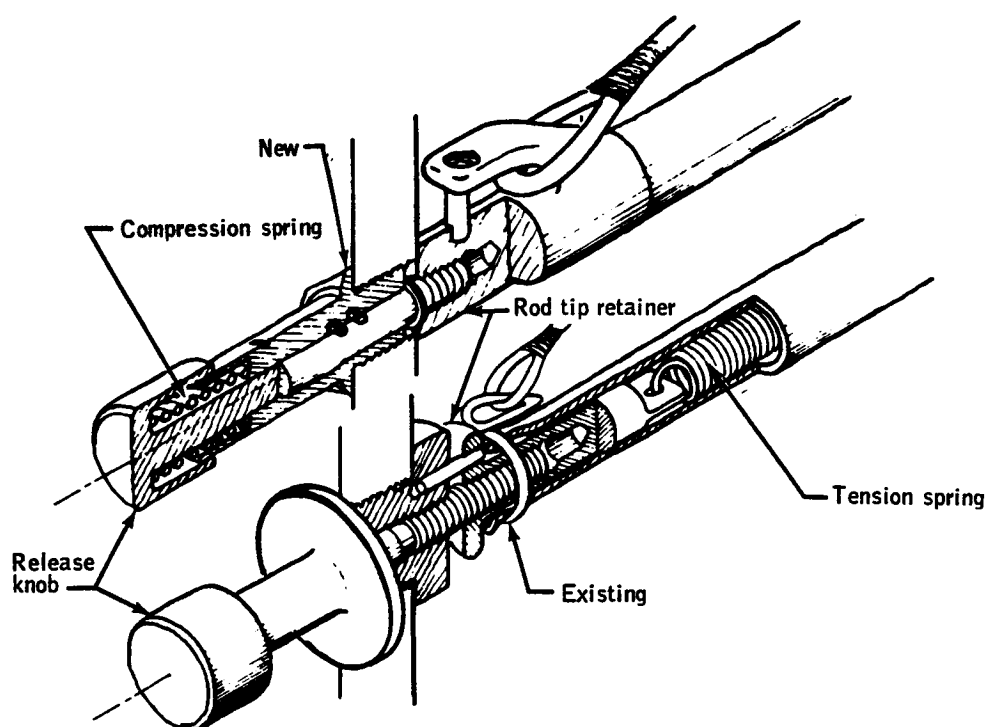
Figure 3-5.- Telescoping rod lock and tip design.

The telescoping rod tip retainers are attached to the rods by springs which are extended several centimeters in locking the rod sections together (fig. 3-5). Release of these retainers with the spring fully stretched imparts a shock force on the rod locks. The design is such that shock loading can trip the lock. The design of the rod locks and retainers on the new parasol has been changed to provide a more positive lock and to eliminate the shock force (fig. 3-5).

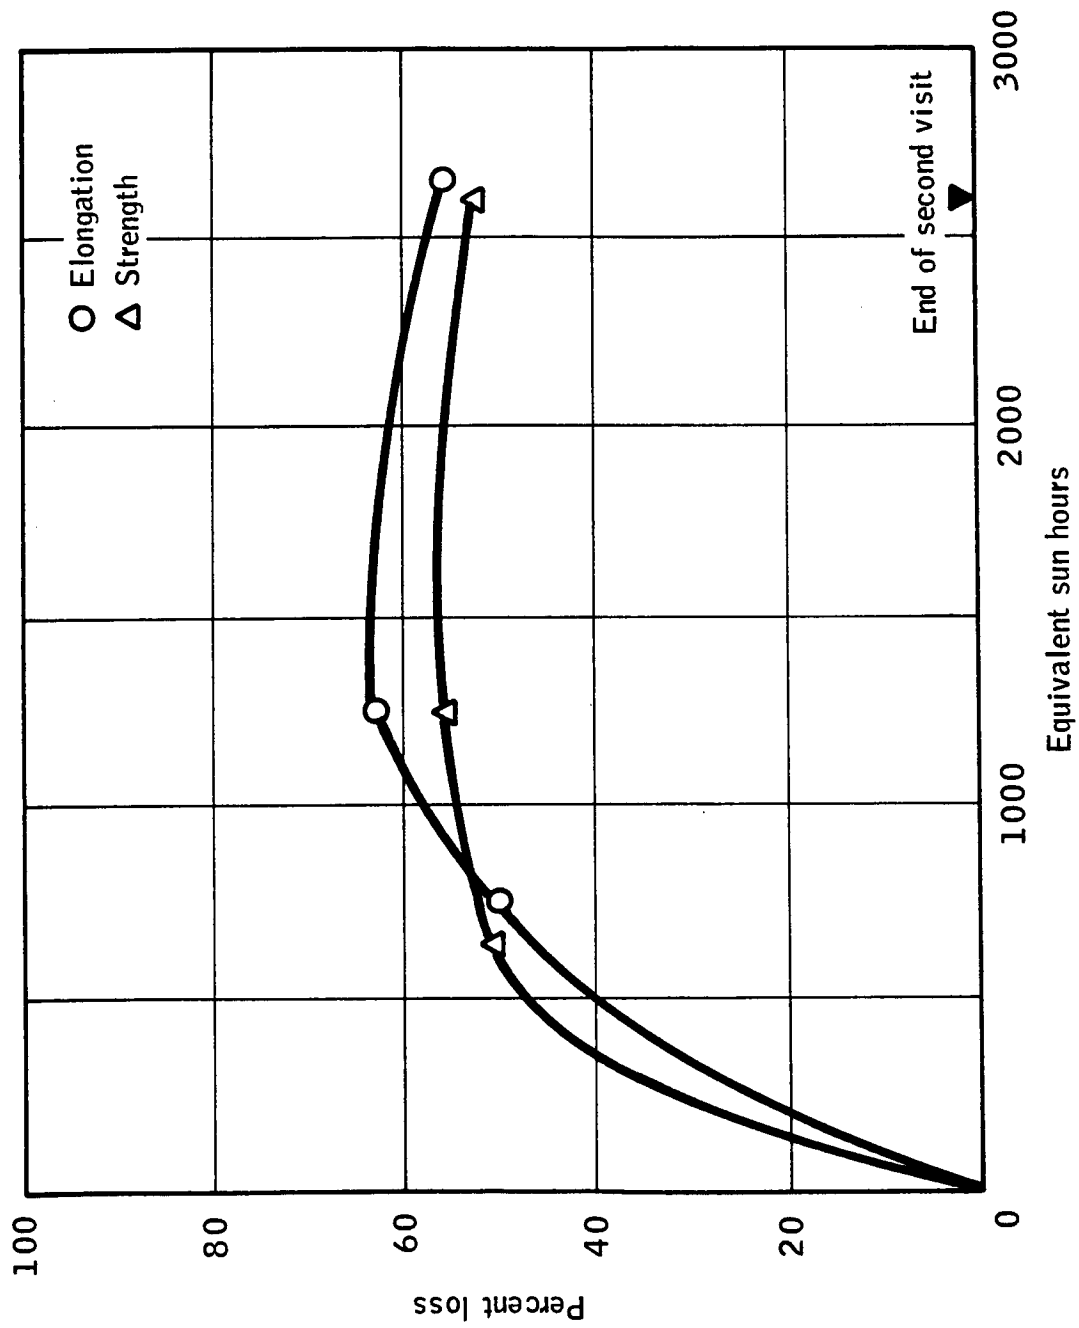
Figure 3-7. - Effect of ground simulation of sunlight on strength and elongation of orange rip-stop nylon.

Ground tests of the canopy material with simulated sunlight indicated that the nylon would lose strength with exposure to sunlight. However, observations made by the crew during the flyaround inspection and comparison of virgin nylon with nylon exposed to 500 hours of equivalent sunlight (end of first visit) indicate that the ground simulation does not represent the actual exposure conditions. The material is not being affected as tests indicate as gaged by the change in color. The color must change before the strength changes since the dye protects the nylon from ultraviolet rays.

The virgin nylon is bright orange in color. The sample exposed to simulated sunlight for 500 hours changed to a dull gold color. The crew's comment upon examination of these two samples was that the parasol looks like the virgin sample in color, except that it had less sheen.

Figure 3-7 is the effect of ground simulation of sunlight on strength and elongation of the orange rip stop nylon material. The 50 percent remaining strength (4465 gram/cm) after 2600 equivalent sun hours exposure (end of second visit) is more than adequate to satisfy structural requirements (892 gram/cm). The 50 percent remaining elongation (19 percent) is more than adequate to satisfy structural requirements (10 percent). Examination of samples yield no evidence that any loose nylon particles are being created which could cause contamination of experiments. The adherence of any surface "crust" (weak nylon) is still quite good after 2600 hours and appears to have stabilized.

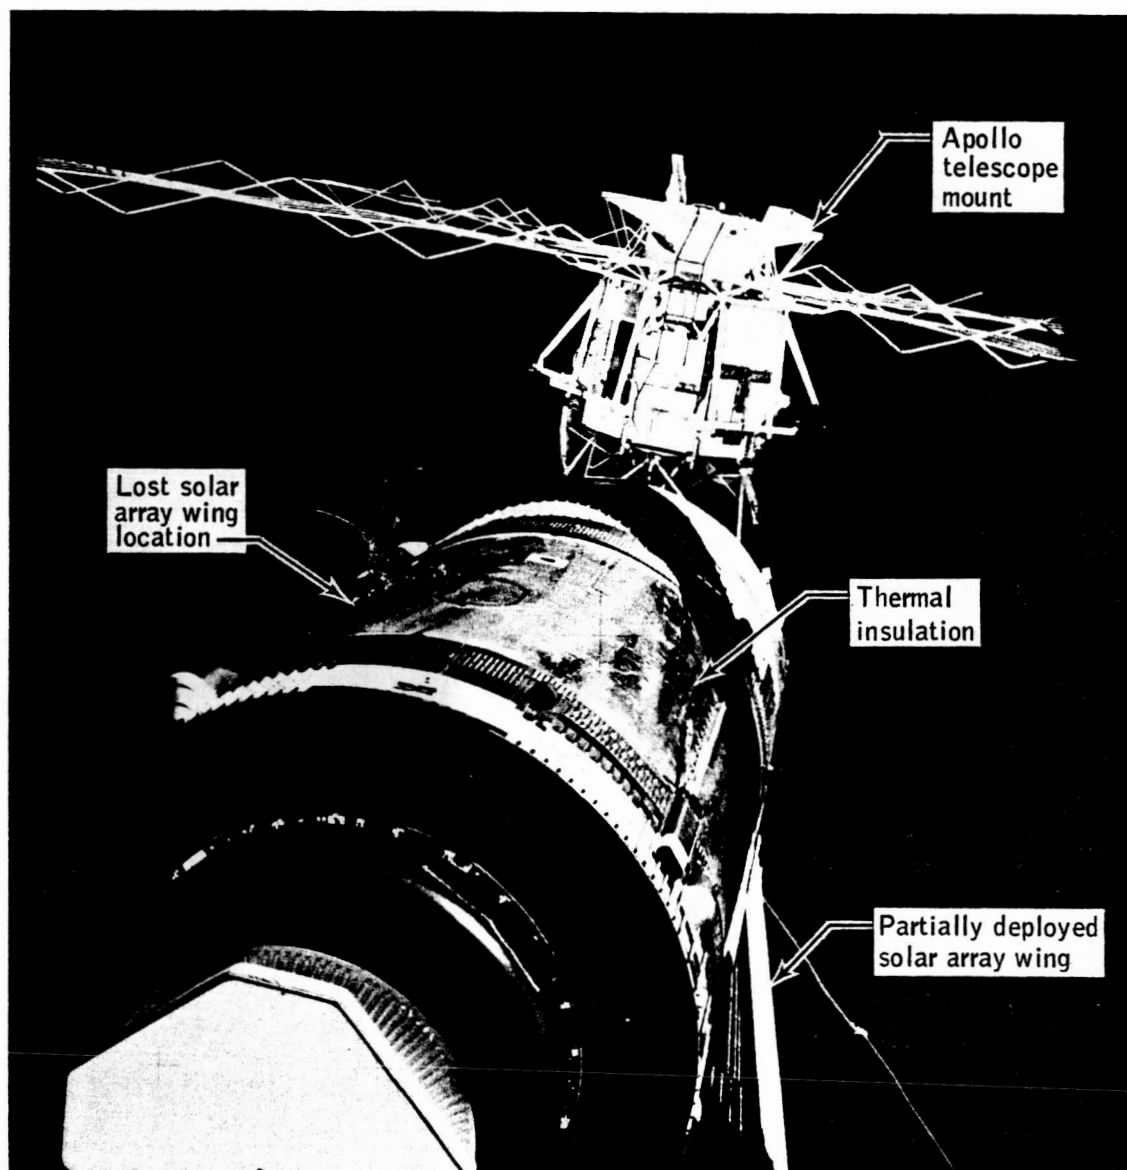
Figure 11-3.- Saturn workshop prior to docking.

Figures 11-3 and 11-4 are examples of 70 mm photography. Figure 11-3 is a picture of the Saturn Workshop showing the configuration prior to command and service module docking. Figure 11-4 shows the Saturn Workshop configuration after extension of the wing 1 solar arrays and deployment of the Skylab parasol.

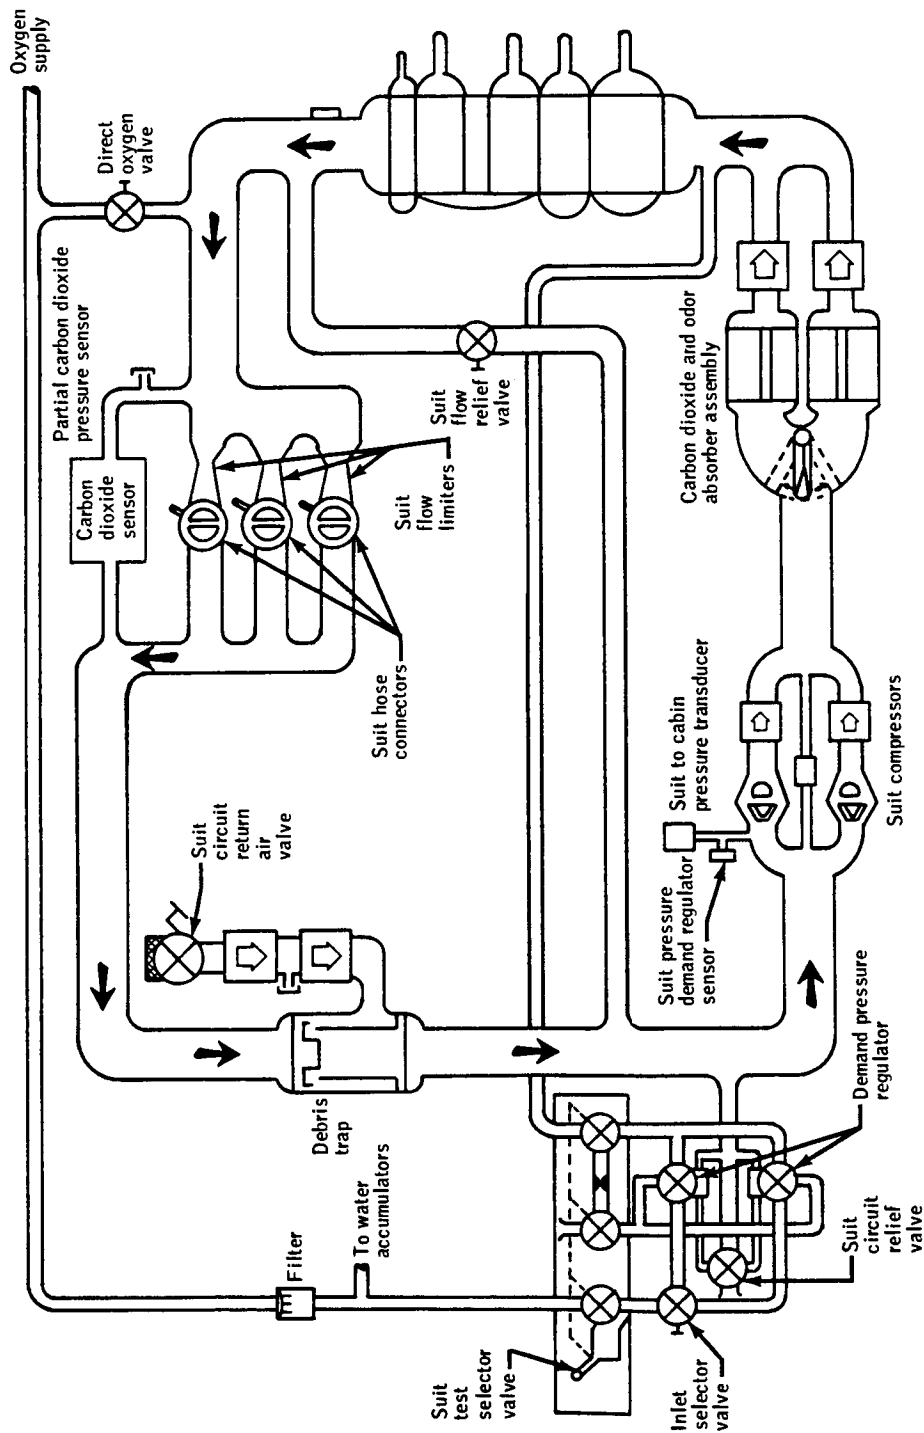
Figure 17.1-1.- Suit circuit.

The pressure decrease could only have been caused by leakage from the suit loop into the cabin. Also, as the inlet side of the compressor was below the cabin pressure, the leak must have been at a point where the suit loop pressure was above cabin pressure, that is, between the compressor outlet and the suit outlet.

Several possible failures could have caused leakage in this part of the suit circuit. First, one or more of the suits could have had a low-pressure leak which resulted in the suit and cabin pressure being equal at the point of the leak. This would create a negative pressure at the compressor inlet where the pressure transducer is located. However, post-flight tests showed the low pressure suit leakage to be too low to have caused the problem. Second, the suit circuit could have had a low pressure leak at a seal or joint. However, no such leak was found in post-flight tests. Third, the interface between the suits and the suit circuit could have had a low pressure leak. This interface was tested and leakage was acceptable. The connectors from the suit hose to the command module suit circuit were inspected after the leakage test and were normal.

The only component that displayed excessive low pressure leakage during postflight testing was the suit circuit air return check valve. However, this valve is located near the pressure transducer in the suit circuit and could not have caused the negative pressure.

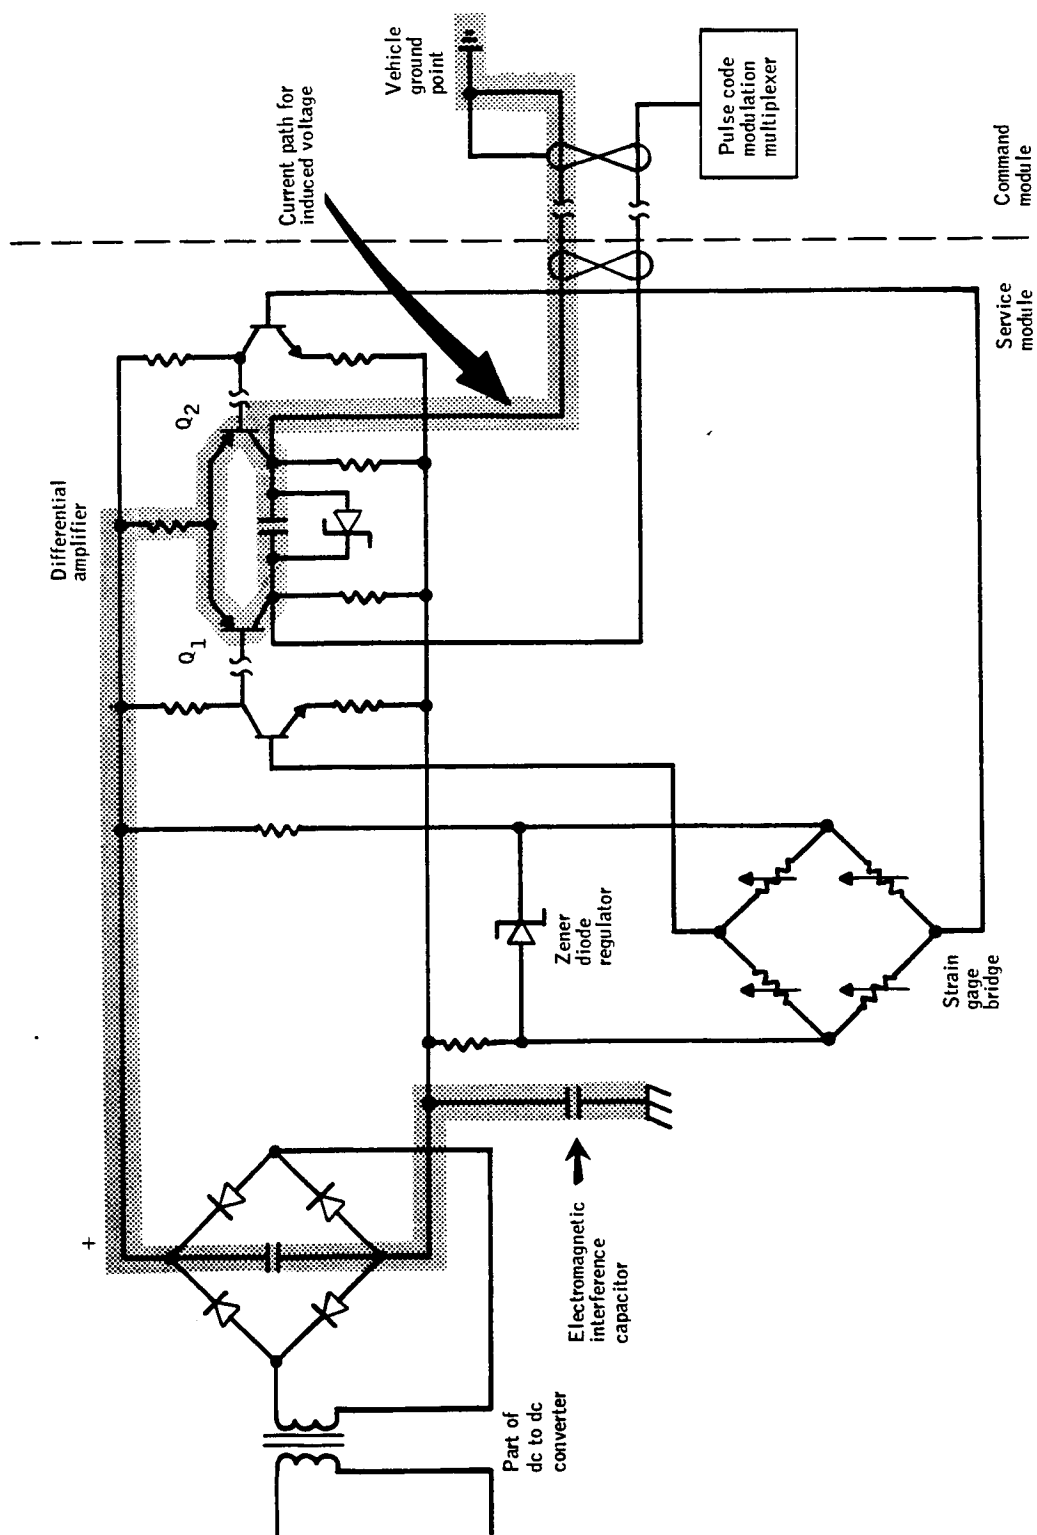
Figure 17.1-2.- Propellant quantity measurement circuitry.

All four quantity measurements on Apollo 12 failed as a result of the vehicle being struck by lightning during the launch phase. The launch umbilical tower on the second visit vehicle was also struck by lightning during ground checkout and four of the five quantity measurements failed (the propellant storage module was not flown on Apollo vehicles). Since the umbilical tower was struck by lightning the night before launch, the failed quantity measurements probably resulted from this lightning strike.

Analysis of the transducers from the second visit vehicle after the lightning strike showed that in each case, one of the two differential output transistors (Q1 and Q2 in fig. 17.1-2) was shorted. (The Apollo 12 and first manned vehicle transducers were not recovered as they were located in the service module).

The quantity transducer contains an electromagnetic interference capacitor that is connected between the negative output of the signal conditioner power supply and vehicle structure in the service module (fig. 17.1-2). Similar transducers located in the same area as the quantity measurement transducers do not use an electromagnetic interference capacitor and did not fail. The negative side of the differential amplifier and the shield of the cable that connects the signal conditioner to the pulse code modulation system are connected to ground and structure in the command module. Lightning induced voltages between these two ground points must, therefore, be imposed between the collectors and emitters of the two differential output transistors, with the weakest transistor of the two short circuiting (fig. 17.1-2).

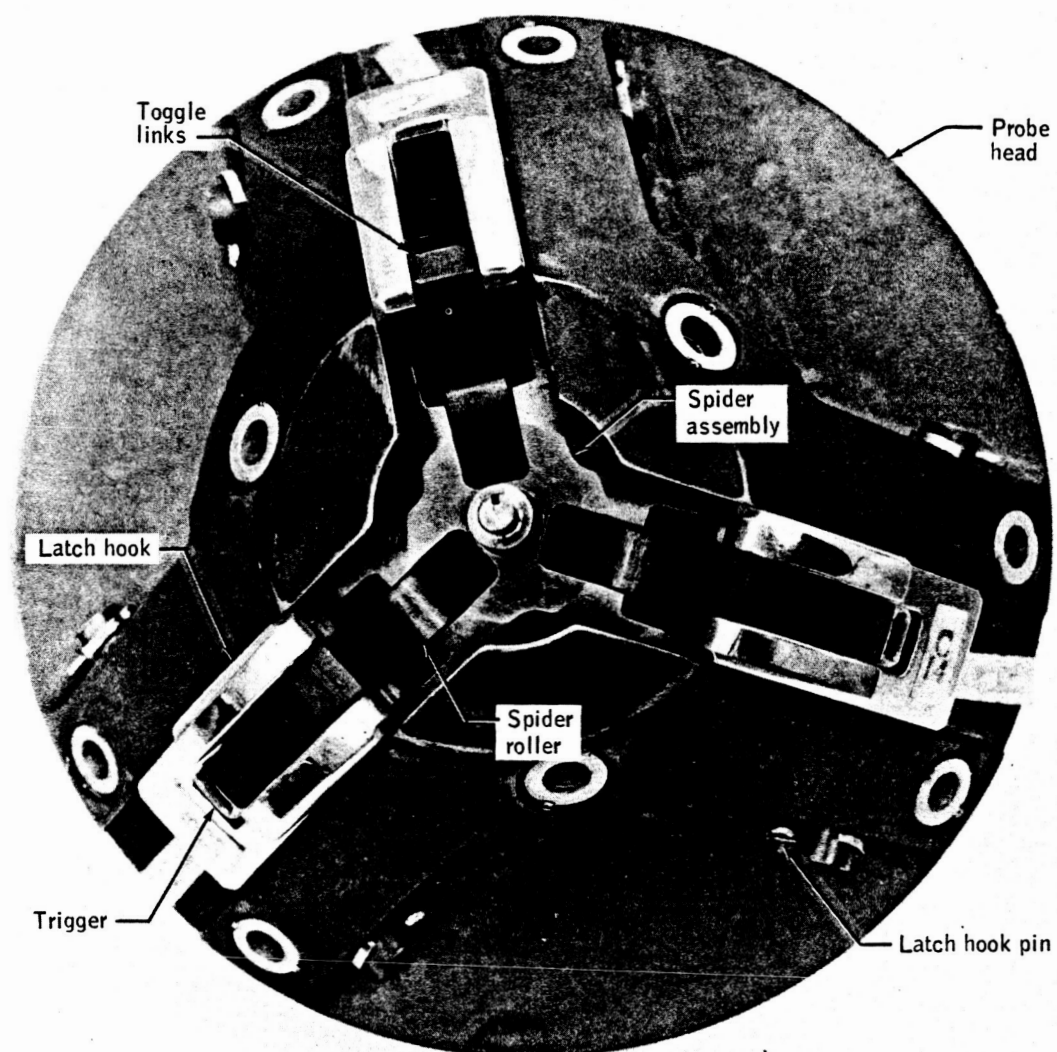
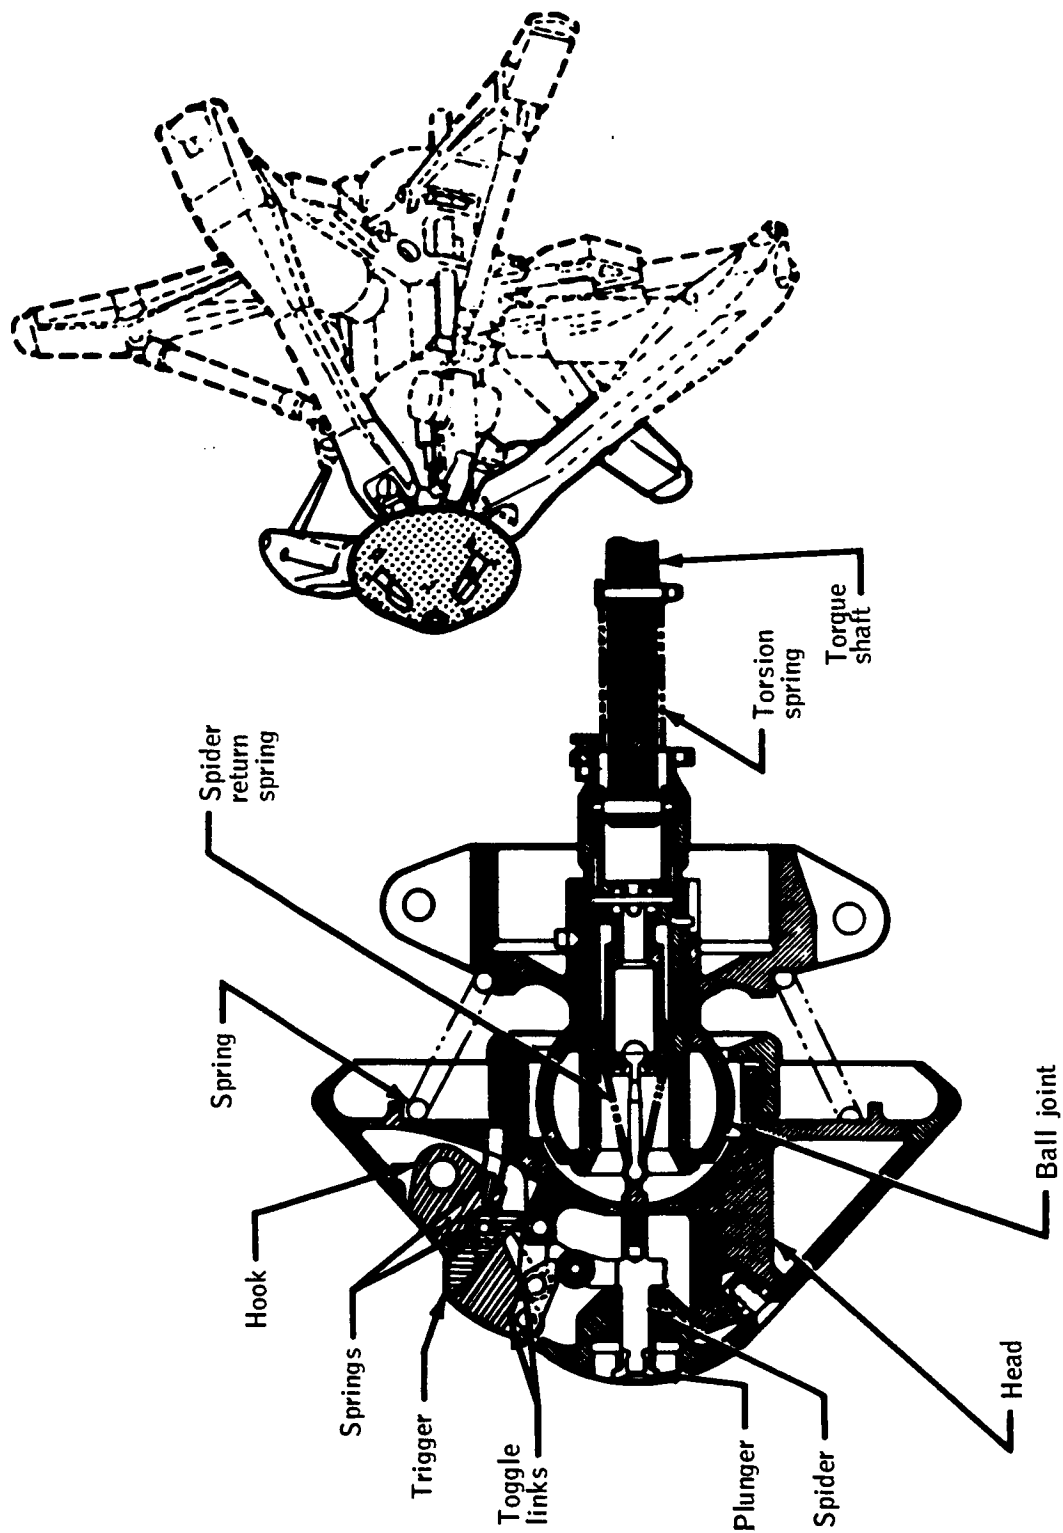
The probe capture latch assembly (fig. 17.1-5) is contained within the probe head and provides the initial coupling between the command module and workshop. The assembly (fig. 17.1-6) consists of three latch hooks which are pin mounted in the probe head and spring loaded such that the hook protrudes beyond the surface of the probe head. Opposite each of the latch hook pivot points is a two piece toggle link that connects the latch hook to a fixed point on the probe head.

The docking problem was similar to an anomaly that occurred on the Apollo 14 mission. Although no data are available for the first visit vehicle problem, an assumption was made that the docking contact conditions were such that capture should have occurred.

A power on failure of the latch release motors as well as binding or jamming of the cam, torque shaft, or actuator were eliminated as the failure mode because electrical power data were normal and the crew verified that the torque shaft rotated freely. Based on the crew's observation of the latch configuration following probe removal and the fact that the crew could manually reproduce the anomalous position of the stuck latch hook, the problem was isolated to the probe head. The problem was further isolated to the capture latch hook because there was no apparent binding or stickiness of the capture latch spider, nor could any visible damage or contamination be detected.

Possible causes of the latch malfunction that cannot be eliminated are:

- a. Contamination causing binding between the hook and the housing.
- b. The slot in the housing may have been wider than the slot in the cap, thereby allowing the hook pin to be trapped (fig. 17.1-11). During inspection of the command module 117 docking assembly, this condition was noted.

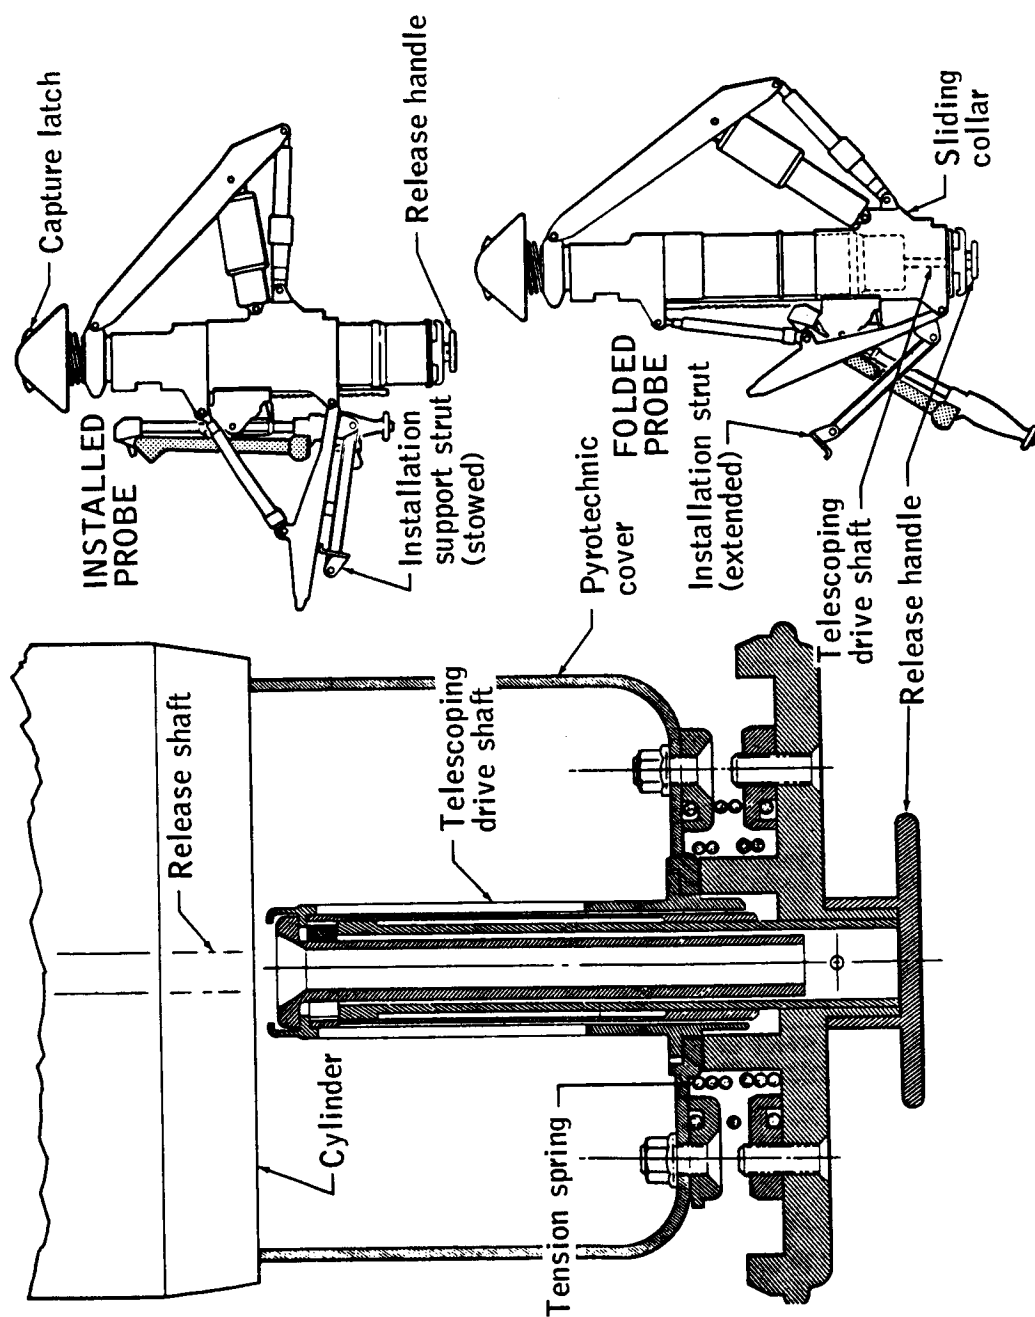
Figure 17.1-10.- Capture latch release.

The capture latch release handle (fig. 17.1-10) is located on the aft end of the probe and provides a means for manual release of the capture latches when the probe is in the retracted position. The probe must be retracted for the capture latch torque shaft to mate with the keyed female telescoping drive shaft. The release handle is secured on the pyrotechnic cover by spring clip detents and a manual locking lever. Normally, prior to folding the probe for removal from the command module tunnel, the release handle is unlocked and pulled from the spring clips.

As the probe is folded, the sliding collar travels aft, contacts the release handle, and extends the telescoping drive shaft. The handle is then accessible for manual rotation to release the capture latches.

Should the docking probe be retracted with the capture latches in the cocked position, the torque shaft will not be properly indexed with the keyed female telescoping drive shaft. This would result in damage to the torque shaft and possibly to the command module forward hatch ablator. Since the emergency docking procedure requires retracting the probe with the capture latches in the cocked position, the pyrotechnic cover was removed before attempting this procedure. Cover removal requires depressurizing the cabin, removing the command module forward hatch, and manually removing of the pyrotechnic cover.

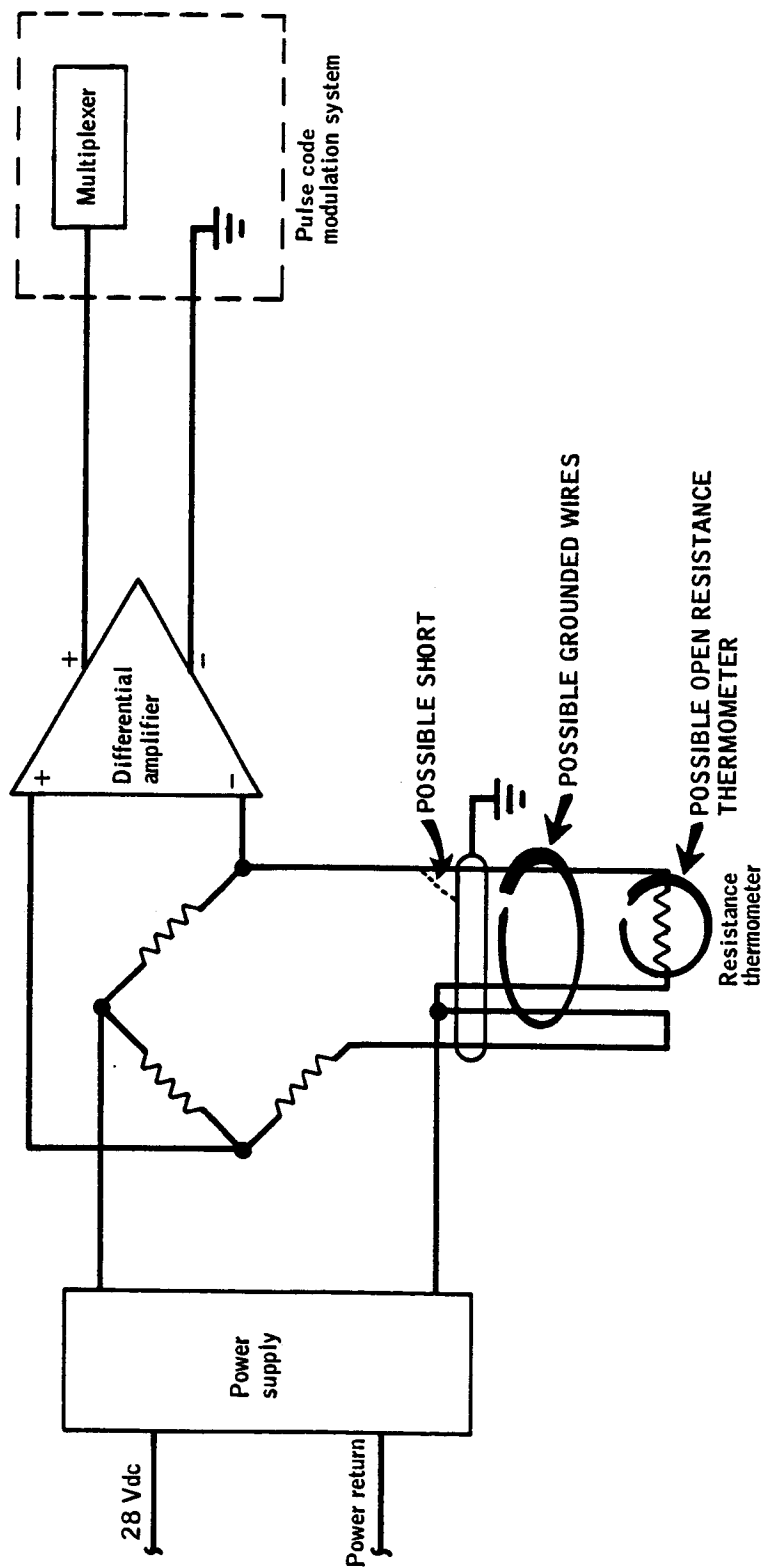
Figure 17.1-13.- Engine temperature measurement circuit.

The transducer (fig. 17.1-13) is a platinum resistance thermometer that operates in a resistance bridge. The transducer is connected to the signal conditioner by a twisted shielded four wire cable. Two of the four wires are connected to the resistance thermometer and the remaining two are shorted together to cancel errors introduced by wiring resistance.

Several possible failures could have occurred. First, the resistance thermometer circuit may have become open. If this occurred, the resistance bridge would have been unbalanced in a direction to cause the off scale high indication.

A second possible failure is a short to ground in any one of three of the four wires in the twisted shielded quad cable. Such a short would tie the differential amplifier negative output to the negative input through the ground path and drive the amplifier to maximum output, giving the off scale high indication.

The transducer cable shield is connected to ground at the signal conditioner. The shield connection is made by crimping two ferrules around the cable, the first under the shield and the second over the shield. Shorts have previously occurred because the inner ferrule was too small for the wire bundle and cut through the wire insulation during assembly

(fig. 17.1-14). During subsequent operations, the wire conductor shorted to the inner ferrule. When this problem was first identified, the assembly drawing was changed to allow the use of a ferrule having a larger inner diameter. In addition, a post-assembly shield to conductor resistance test was added. The failed quad B transducer was assembled using the small ferrule and was subjected to the resistance test; however, the wire insulation could have been cut through with the conductor positioned in the ferrule in such a manner that a short did not exist when the resistance was measured.

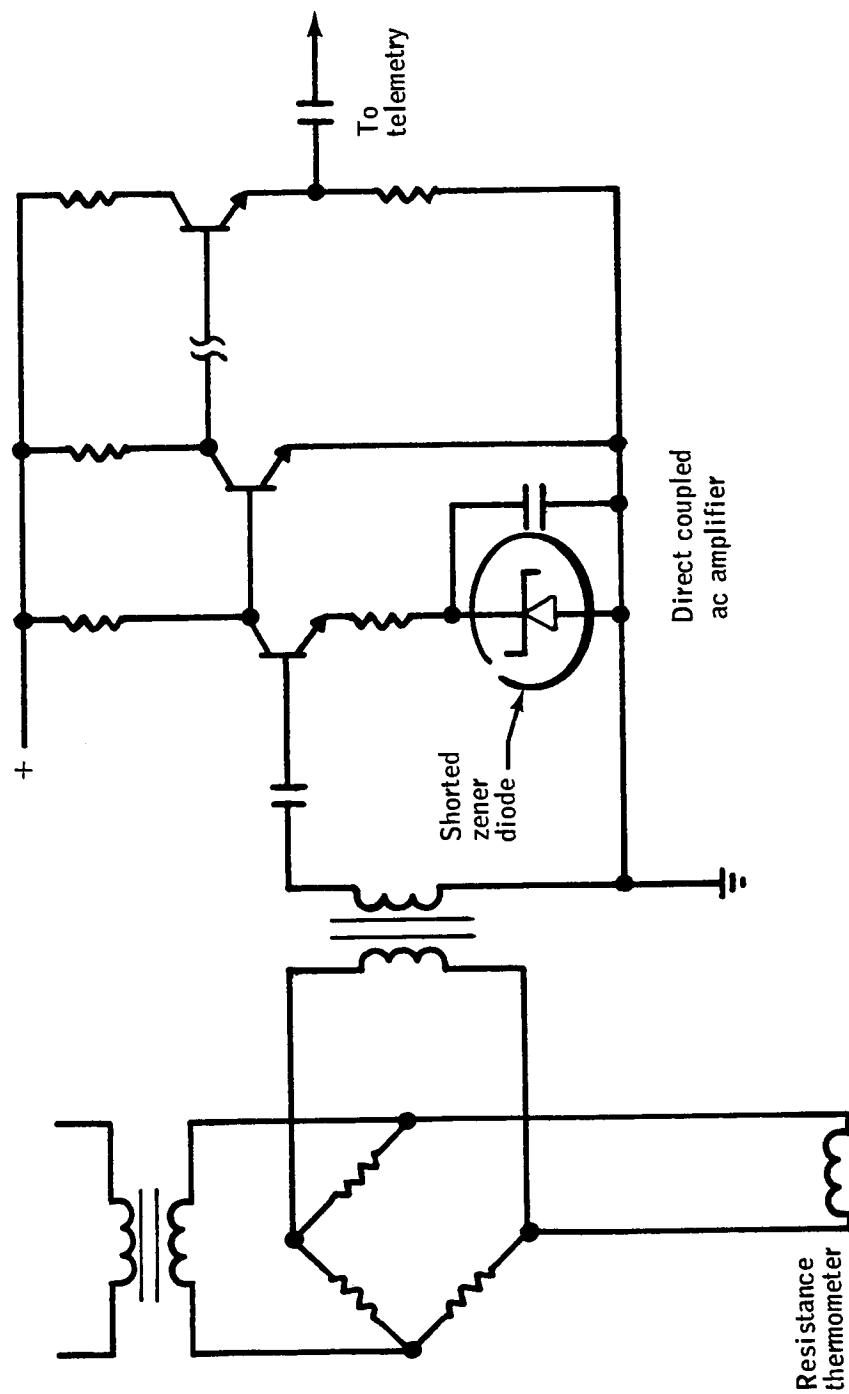
Figure 17.1-15. - Secondary evaporator outlet temperature measurement circuit.

The sensor is a copper resistance thermometer encased in a probe that is immersed in the water/glycol coolant. The thermometer is connected as one leg of a bridge circuit which is excited by a 2.7 volt ac power supply. The bridge output is then amplified and rectified by the signal conditioner and supplied to the pulse code modulation system as a 0 to 5 volt dc signal. The signal is also supplied to a cabin meter through a selection switch.

Postflight testing showed a zener diode, which sets the operating point of the signal conditioner ac amplifier, shorted (fig. 17.1-15). Since the ac amplifier stages are all direct coupled, the operating point of each stage was shifted, and the last stage was turned full on. Under these conditions, the amplifier gain was reduced, the waveform was clipped, and the rectified output signal was low.

The diode junction was shorted by conductive contamination inside the diode glass body. The contaminant particle appeared to be a sliver of silicon that had broken off the semiconductor die and migrated to the junction, shorting across the junction. The sliver was fused to the die surface, bridging the junction.

Component screening tests may not detect this type of contaminant since the contaminant sliver may break off of the die at any time, even after the component is assembled into the amplifier; consequently, no corrective action is possible. In any event, since secondary coolant loop performance can be determined by using other measurements. No corrective action is required.

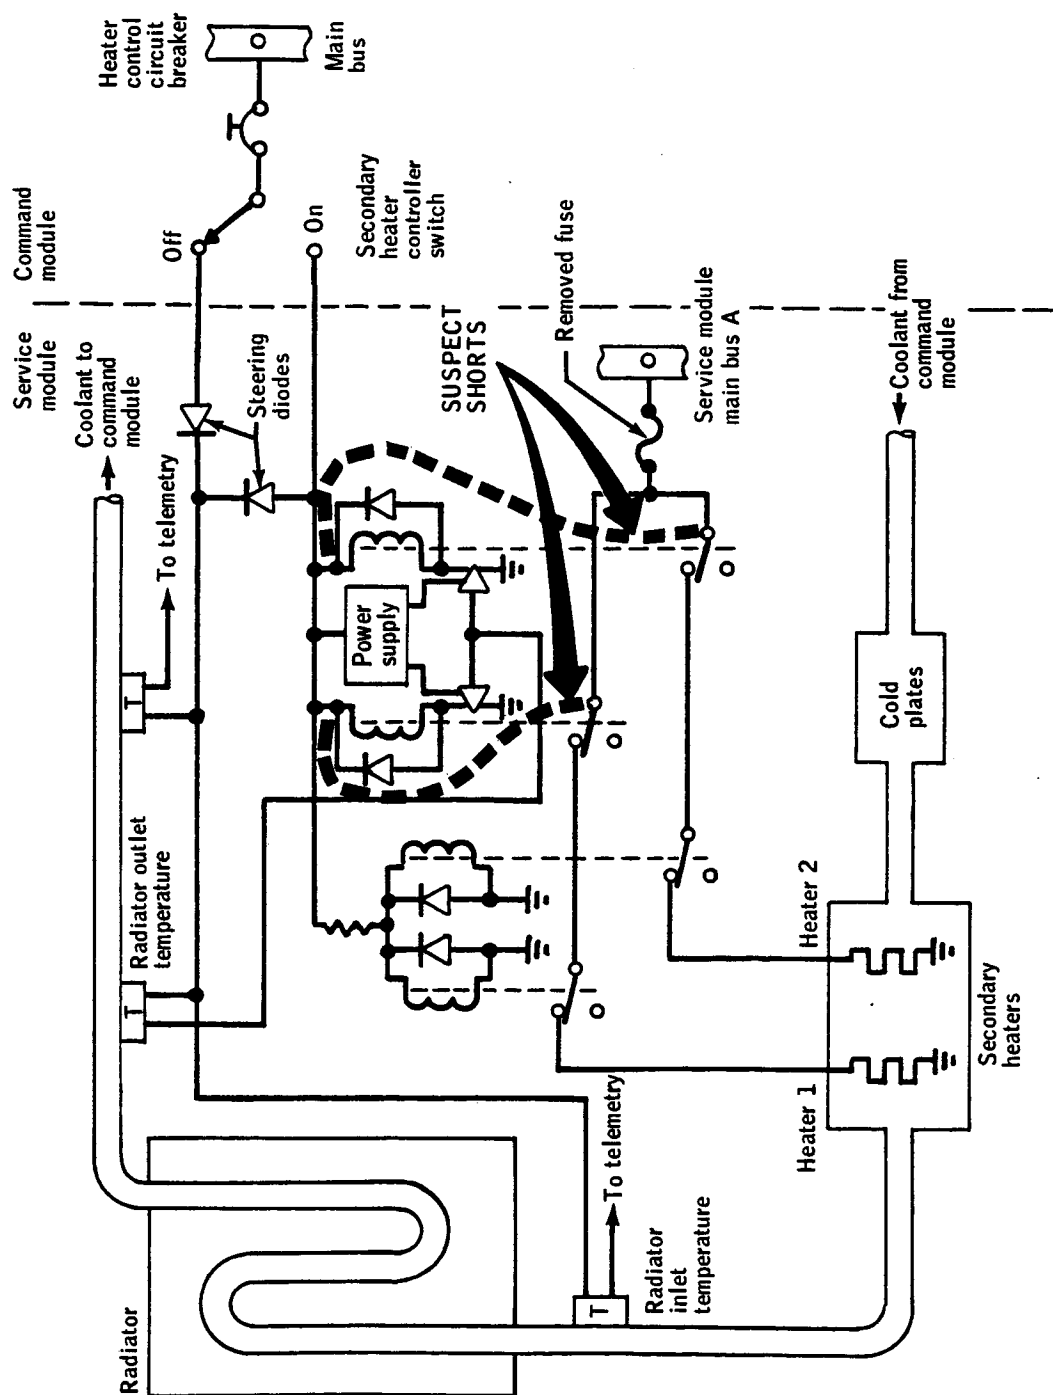
Figure 17.1-18.- Secondary radiator heater control circuit.

The two temperature measurements operated while the secondary heater controller switch were off and the associated circuit breaker was open. Consequently, the cycling could not have been caused by a defective switch, circuit breaker, or steering diode. Also, postflight tests showed that the command module wiring was normal, which indicates the problem was in the service module.

The most probable failure was a short between the cathode of the relay spike suppression diode and the contact wiper in one of the two heater control relays (fig. 17.1-18). This was concluded from a controller which was disassembled. The diode lead routing on all relay headers was as shown in figure 17.1-19. Note the marginal clearance between the terminal and diode lead. Assuming a short between the close clearance in this figure, the heater controller would be powered from the service module main bus A (fig. 17.1-18).

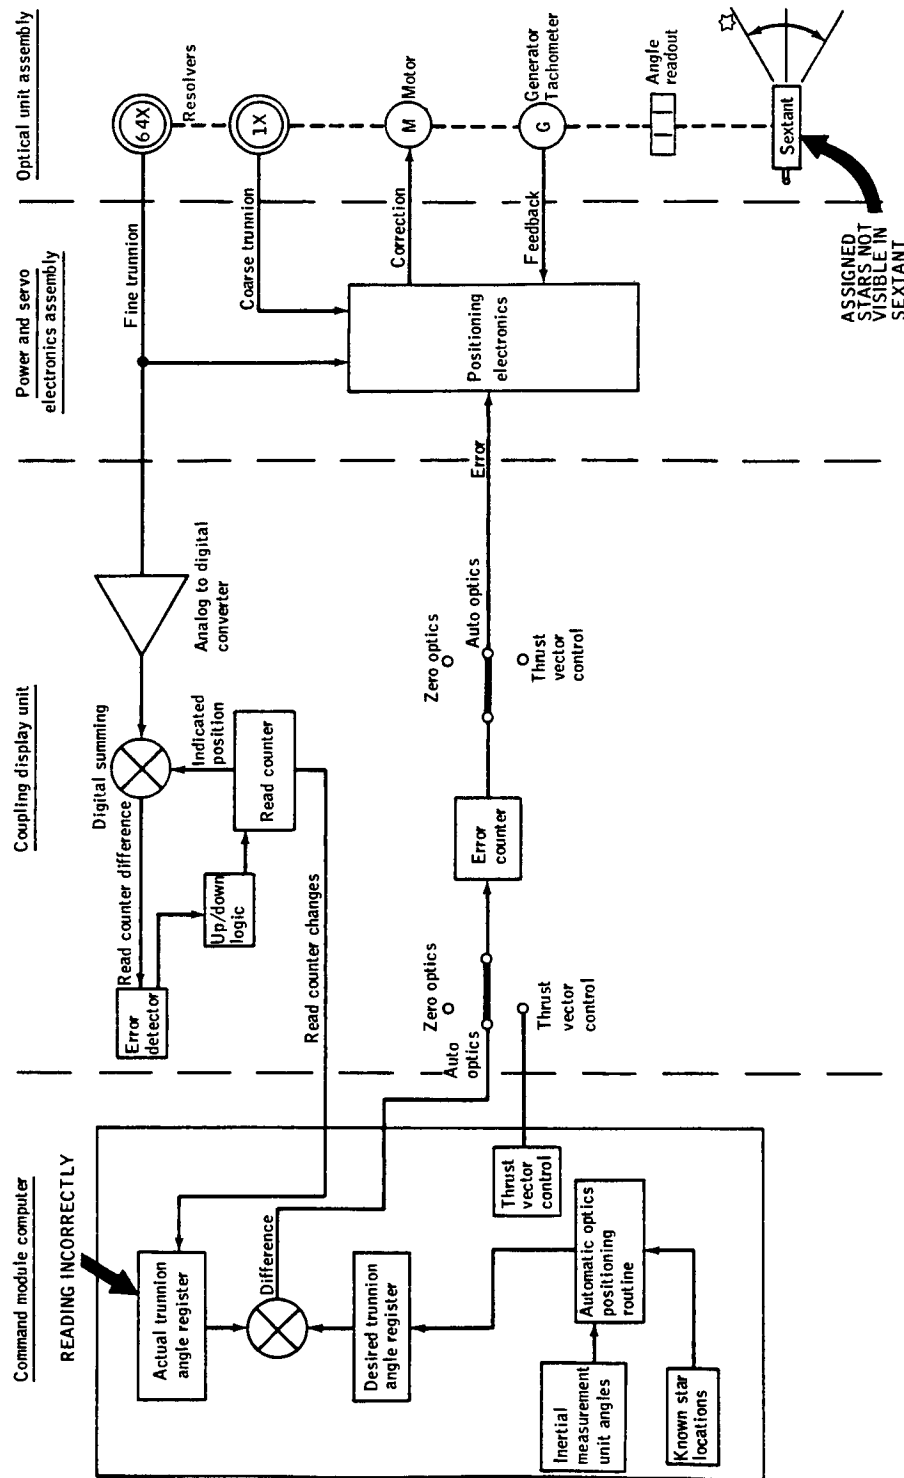
Figure 17.1-21.- Simplified optics - coupling display unit - computer interface (sextant trunnion angle only).

Three times during the visit, the command module computer sextant trunnion angle position information was in error. All three times, the optical loop was in the optics zero mode, and both the shaft and trunnion angles in the computer should have read zero radians. The trunnion errors observed at the three instances were $1/6$, 1 , and $1/2$ radians, respectively. Figure 17.1-21 is a functional diagram of the optics and computer interface. The coupling display unit contains the analog to digital converters which interface the optics with the computer. Resolvers on the shaft and trunnion axes of the sextant provide position signals to the read counter in the coupling display unit. The read counter stores the resolver position data in digital form. Limited data are available for the first occurrence. The second occurrence existed for about five seconds, and the last occurrence about 30 seconds.

Attempts were made to use the optics after each of the last two occurrences. The automatic optics positioning routine in the computer pointed the optics in the wrong position because of the error, and the desired stars were not acquired. At this time, the crew observed that the mechanical position counters on the optics panel agreed with the desired angle in the shaft axis from the computer, but did not agree in the trunnion axis. (Once the erroneous information is stored in the computer, the computer retains that data until the optics zero mode is reselected.) The optics zero mode was reselected and the computer and optics were reinitialized. Therefore, the error was removed. Subsequent use of the optics and the automatic positioning routine was normal. In the zero optics mode, the computer issues no drive commands and the sextant shaft and trunnion angles are driven to zero radians using only the positioning electronics. Should the trunnion angle change (fig. 17.1-21) the associated read counter and resolver no longer agree, and a read counter difference signal is generated. The read counter difference signal causes the read counter to increment or decrement until the angle again matches the resolver signal. As the read counter changes, a series of pulses, each equal to 10 arc seconds trunnion angle, is sent to a computer register that stores trunnion angle data. In this way, the computer tracks the optics position changes.

The indications observed in flight must have been caused by an intermittent condition which caused sextant trunnion angle changes to be sent to the computer (while the optics was in the zero mode), although no actual change in trunnion angle had occurred. The coupling display unit, the computer, and the wiring harness that could cause the intermittent condition are under test, but performance has been completely normal.

The intermittent condition experienced in flight could occur in any of the five read counters. If the intermittent problem were to occur in one of the three gimbal angle read counters, digital autopilot attitude hold and automatic maneuver capabilities would be lost. Control could be restored after the intermittent disappeared by performing a coupling display unit zero operation and existing malfunction procedures. If the condition were a hard failure, the computer would lose all attitude information in the affected axis. However, existing erasable memory programs could be used that would inhibit the computer from using any information from the affected axis.

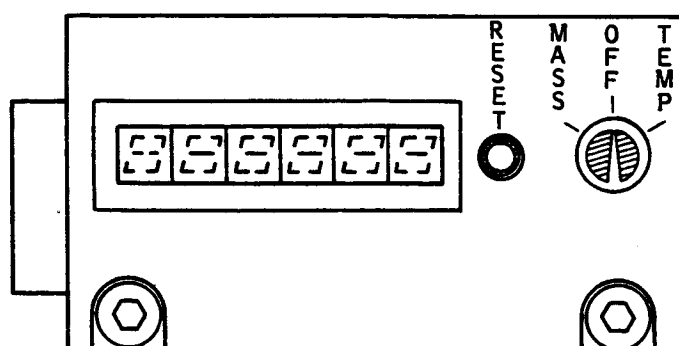
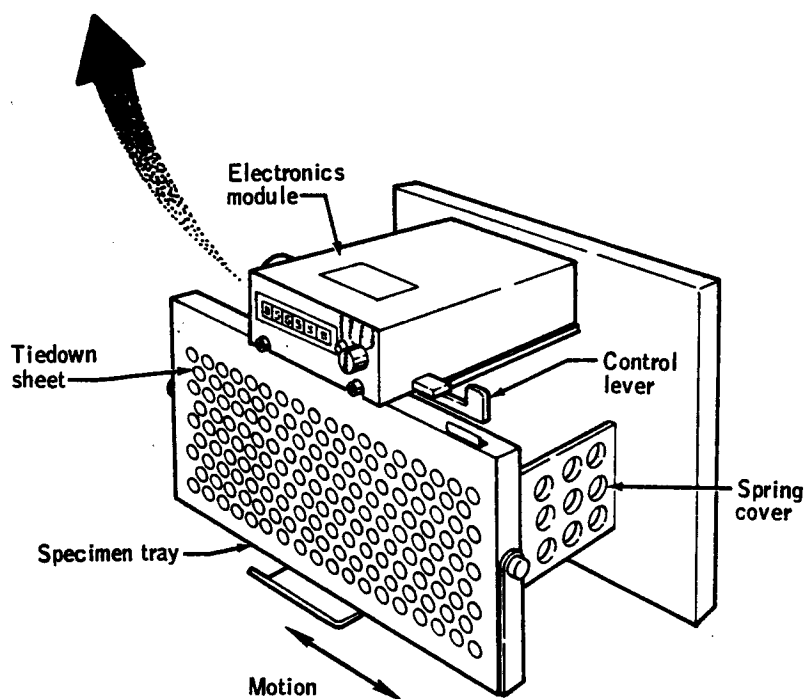
Figure 17.2-1.- Specimen mass measurement device.

The waste management compartment sample mass measurement device was checked out satisfactorily on visit day 3. About 18 hours later, the crew reported that the displays did not illuminate. The reset button was depressed and no reading of mass or temperature was present.

The device had been inadvertently left operating for 16 to 18 hours since the satisfactory checkout. Normally, this would not cause any device problems. However, the electronic module temperature at the time of activation was about 322° K as a result of the thermal condition in the Orbital Workshop. Analysis shows that the temperature of some electronic

components exceeded 366° K because of the constant 15 watt output of the module, and the abnormally high ambient temperatures.

Analysis indicates that the 5 volt power regulator that powers the digital display had failed because of temperatures beyond the survival limits of the solid state electronics.

A replacement electronics module will be provided for the second visit.
